CONNECTICUT RIVER BASIN
BELLOWS FALLS

MINARDS POND DAM
VT00154

PHASE I INSPECTION REPORT
NATIONAL DAM INSPECTION PROGRAM

AUGUST 1978

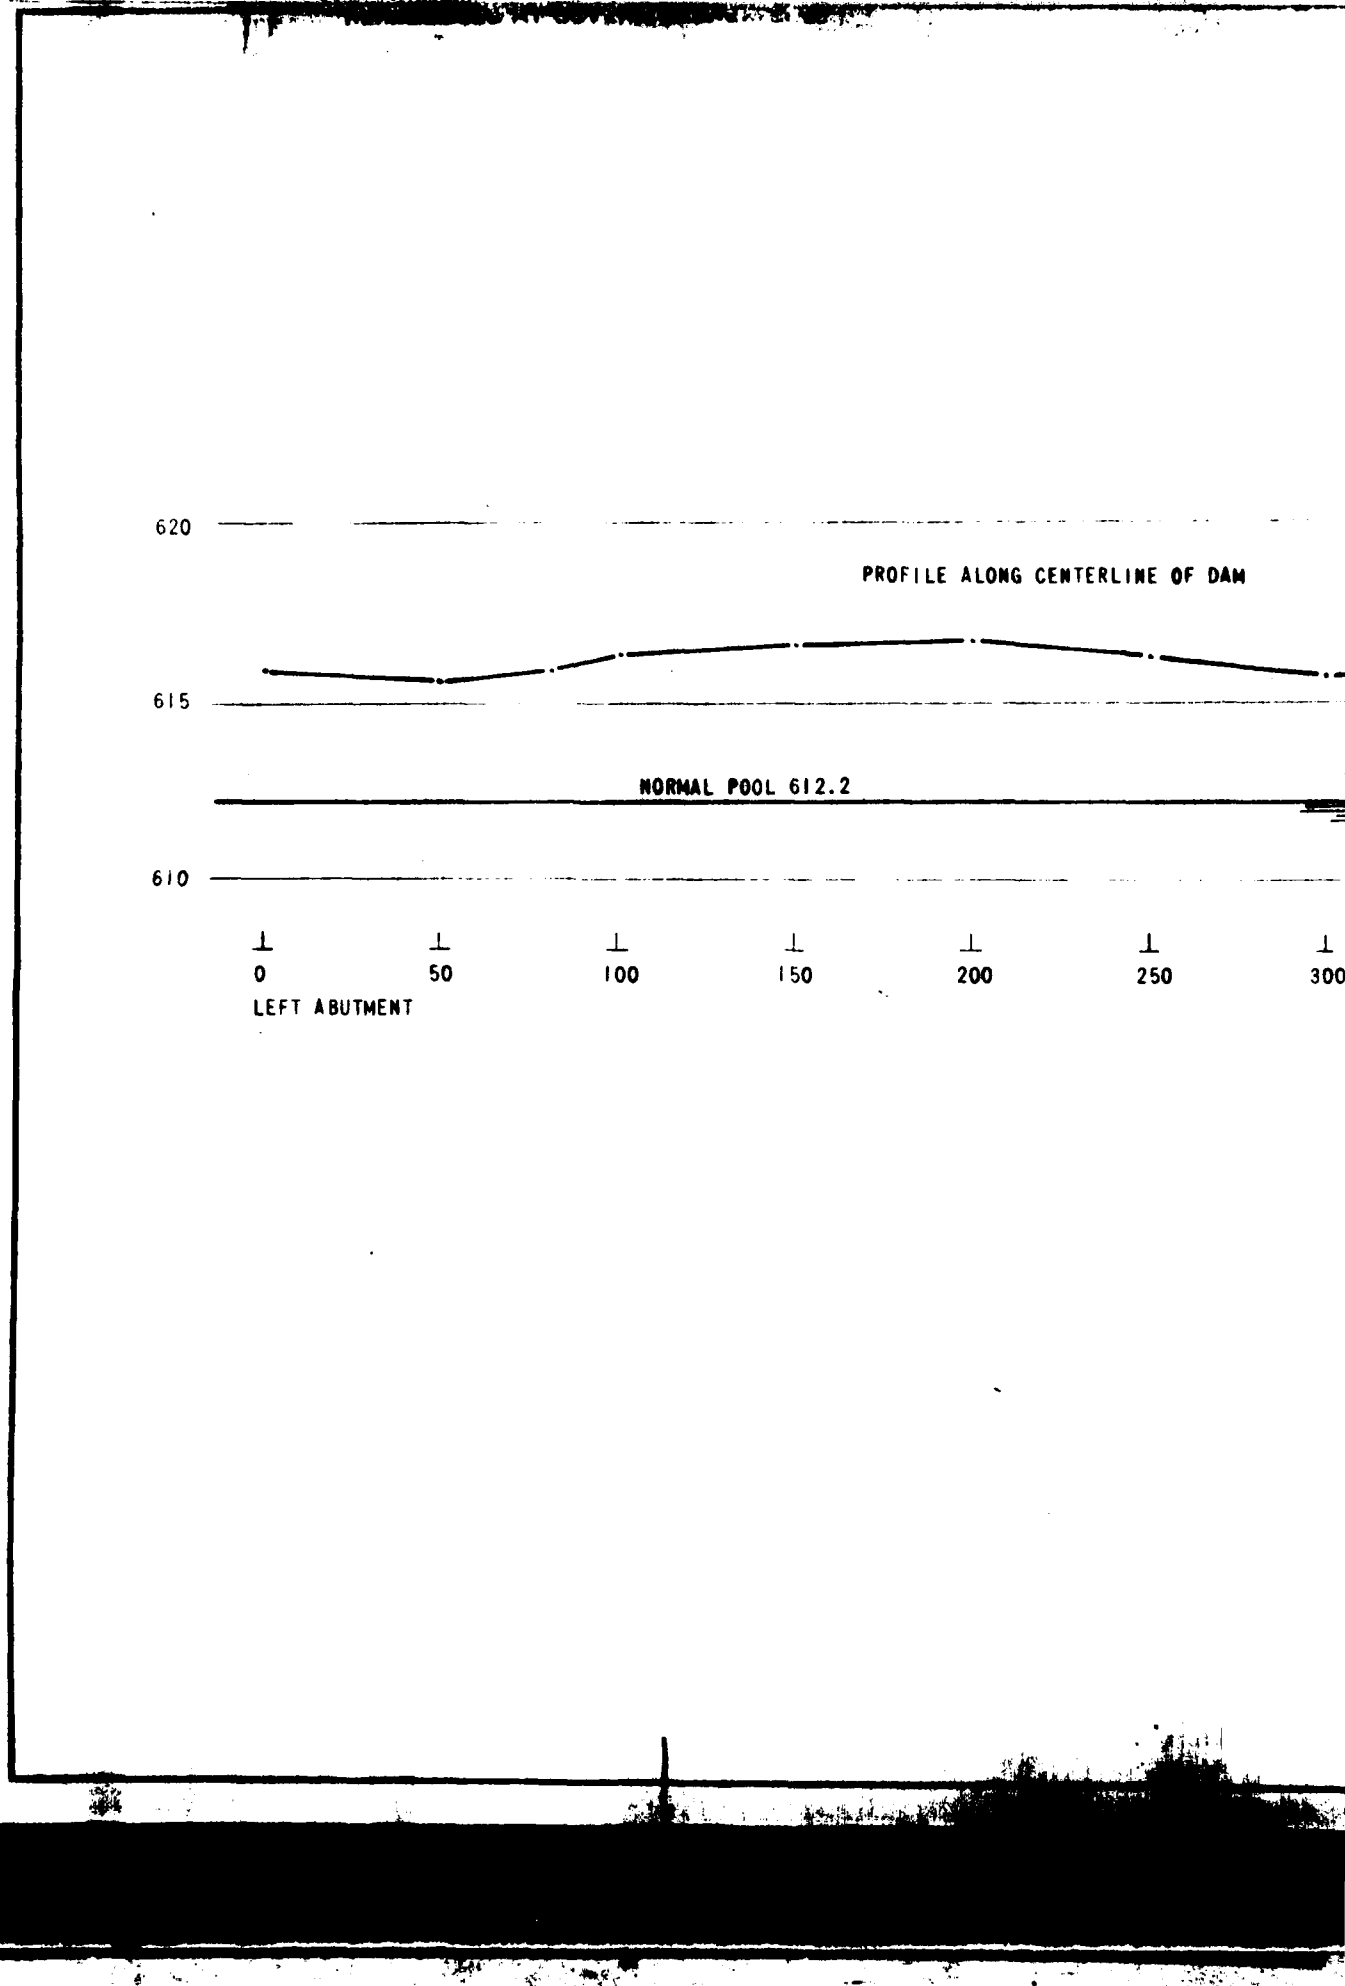
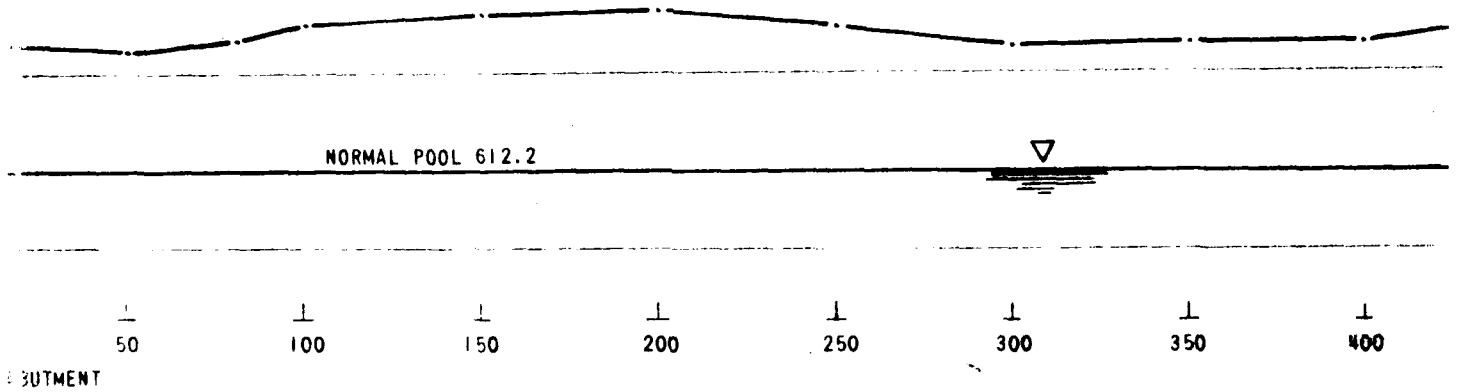
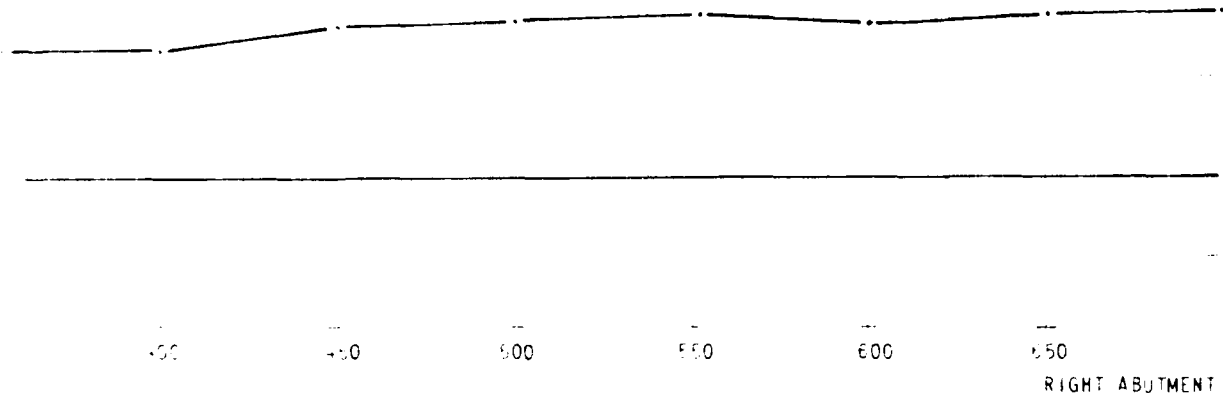
FIGURE 3

The crest is very irregular in elevation (Fig. 3). In addition to the low zone on the left end, there are a few low spots in the crest where runoff concentrates and causes erosion locally on the downstream slope. Also, the downstream crestline is generally a few tenths of a foot lower than the upstream crestline.
